Report Index

INSPECTION CONDITIONS

**5220 Mockingbird Lane
Atlanta, GA 30328**

Inspection conducted by Paul Davidson
GAHI#345-98

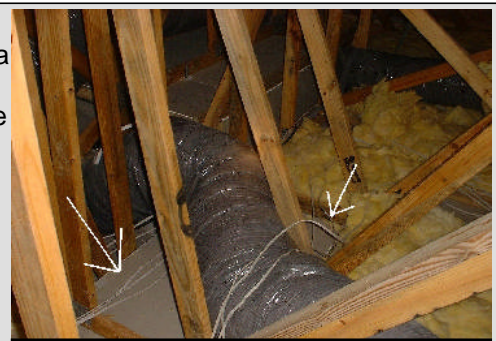
Fiberglass batts, Some insulation is installed unevenly over the kitchen area with poor general coverage. Recommend additional insulation in the attic area to improve energy efficiency.

Insulation missing over kitchen ceiling

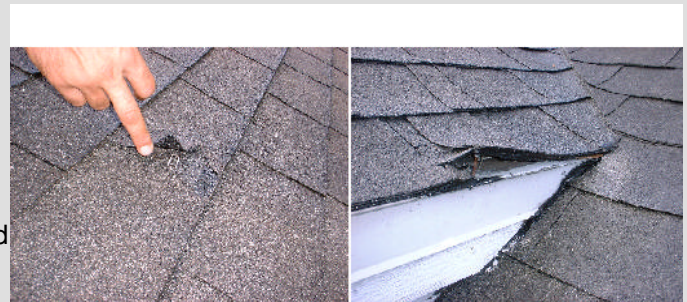
General condition appears serviceable with signs of weathering/curling and aging. [This roof is now 12 years old.](#) Regular maintenance and inspections are advised so you can make reinforcements as needed to prolong roof

Protruding staple - Uplifted edge flashing

life. **Some repairs are needed now.** Nails/Fasteners are protruding from the roof surface at the rear of the roof, and flashing is uplifted and in need of repair at the front right gable. Each of these areas represents a potential area of leakage, if not now, then in the near future. [A licensed roofing contractor should](#)

be called to make further evaluation and repairs as needed.

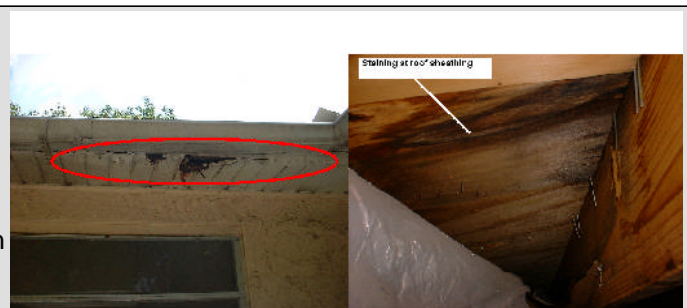
Aluminum. Damage is noted- along the overhang at the left side of the house. **Active leakage is noted within the attic area** under this portion of the roof, as shown in the 2nd photo. A licensed roofing contractor should be called to make further evaluation and repairs as needed.

Damaged Overhang/Roof Problems/Leakage

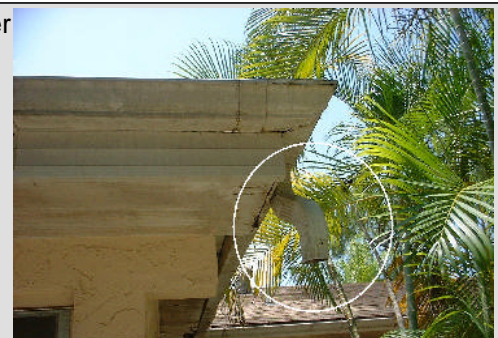
Partial, Damage/Defects viewed Gutter downspout is missing from the left rear corner of the flat porch roof. Some erosion is taking place. Replace as needed.

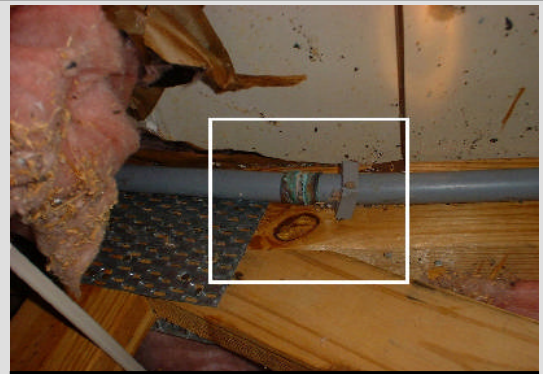
Appears serviceable, however, active leakage is noted at a crimped joint located over the family room. It's is a small drip at this time, but could result in catastrophic failure without warning. For this reason alone, repair should take place without delay. Budget \$200+

Active leak at plastic water pipe in attic

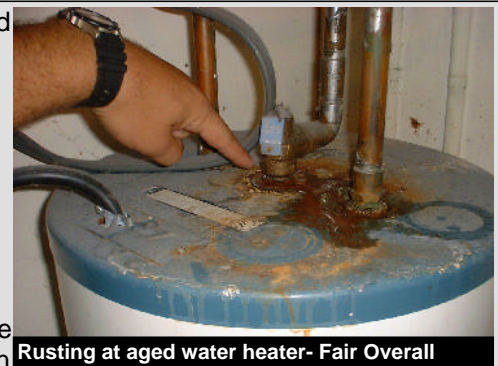
CONDITION: Leakage has occurred at the connected piping above the unit, causing rust to form at the top of the unit. Pressure relief valve noted, not tested, A water shutoff valve is installed but does not appear like it would work, due to rusting. No ongoing leakage is noted, but this unit now exceeds 10 years of age and will likely need replacement in the not too distant future at a cost of \$300 or so. Electric water heaters have expected service lives of 10-15 years in this area of the country.

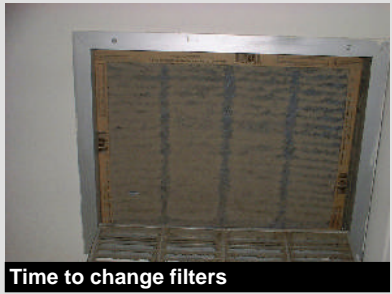
Suggest cleaning/changing filter.

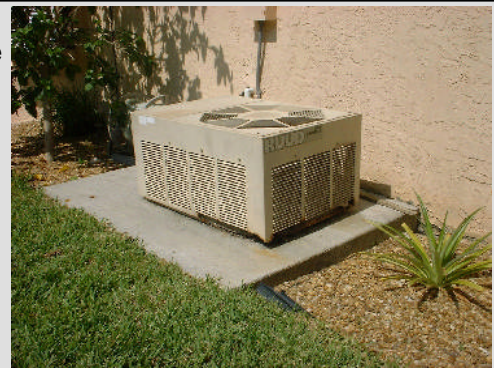
Central, Electric- The air conditioning system is completely separate from the heating system. System is operational, however, we recommend clearing foliage from unit.

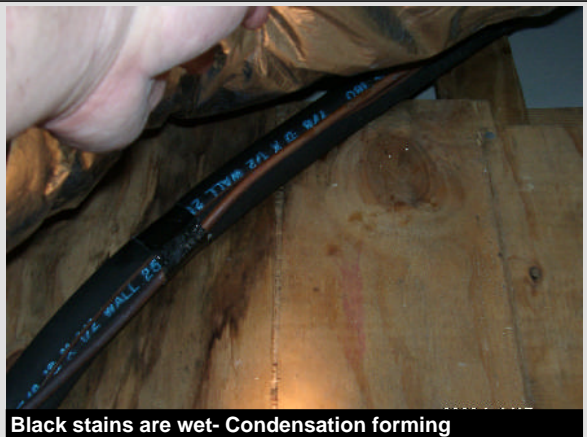
Condensate line runs from the evaporator in the attic over the family room to the right exterior wall. **CONDENSATE DRAIN LINE IS SWEATING:** The condensate drain line from the air conditioning evaporator cabinet (air handler) has a tendency to sweat during hot weather, when the system is operating most of the time. Inexpensive pipe insulation should be added to the first 5 feet of this line to alleviate this condition, which if left

Black stains are wet- Condensation forming

unattended, can cause damage to ceilings. Uninsulated portions of refrigerant suction lines also can result in condensation formation and subsequent dripping and damage to attic ceilings. The remedy is the same, with addition of foam pipe insulation to remedy the problem. At this point, you may want to call a contractor who can offer a warranty on their work to make repairs.

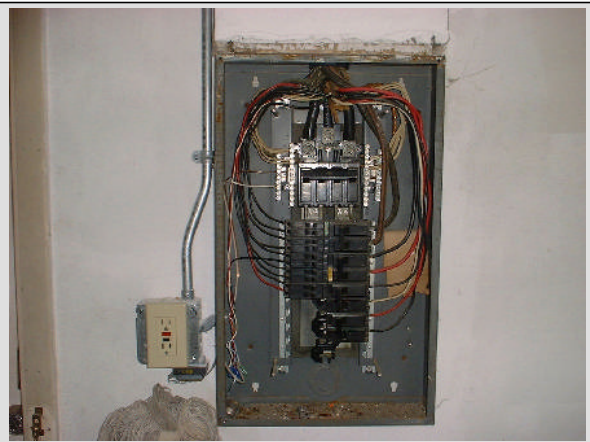
Circuit and wire sizing correct so far as visible, Grounding system is present, but loose clamp at water line or ground rod. Tighten as needed. Unused openings in the panel are missing covers, Panels are without the benefit of complete labeling.

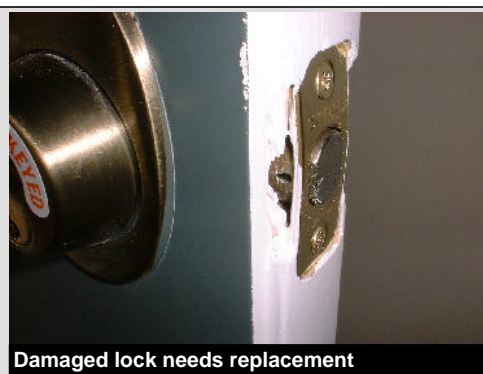
Appears serviceable, Dead Bolt is not operational, due to damage. Replace as needed.

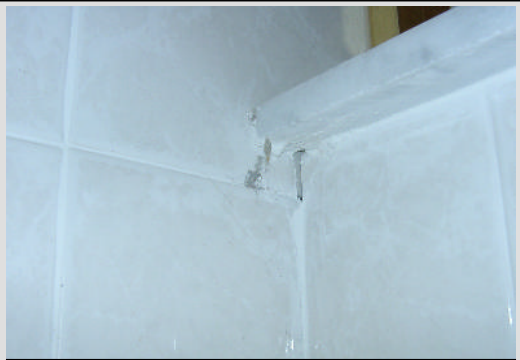
TUB/SHOWER AND WALLS: Tub and shower areas appear serviceable. Cosmetic moisture damage is noted at the wall or floor outside the tub/shower area. Caulking and/or re-grouting is needed to prevent water intrusion. Enclosure appears serviceable, but open gaps are seen under the interior of the shower curb. Caulk and seal all tub and shower areas as a precaution.

Caulk both ends of shower curb interior

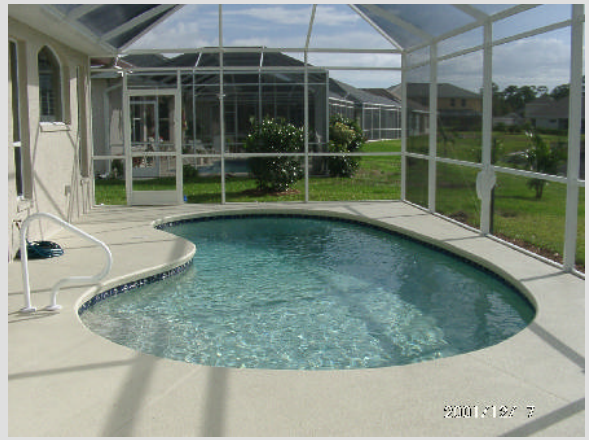
Appears Serviceable, The following was seen: Scale buildup at pool walls is due to excessive calcium in the pool water. Have adjustments made as needed by your pool service company. Mildly discolored surface will need an acid wash in 1-2 years. A few minor stains noted at the surface may or may not be removable.

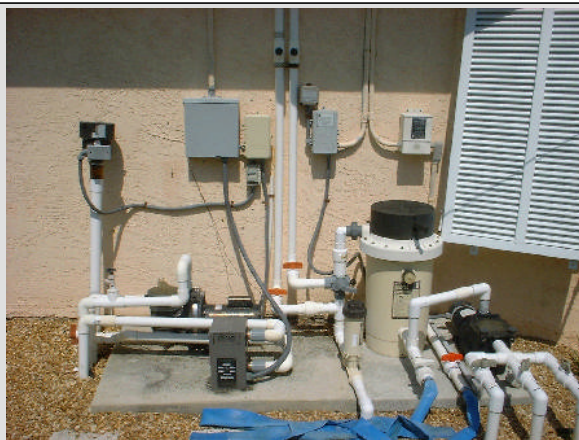
Duraglass II brand pump. 1.5 HP motor. Appears serviceable. A second pump is still in place but disconnected. Apparently there was a portable spa in use sometime in the past. Spa is gone, but old pumping and filtering equipment remains. Make inquiry with the sellers about the abandoned equipment and how it was set up when in use.
