At your request a visual inspection of the above referenced property was conducted on May 23, 2022. This inspection report reflects the visual conditions of the property at the time of the inspection only. Hidden or concealed defects cannot be included in this report. No warranty is either expressed or implied. This report is not an insurance policy, nor a warranty service.

REPORT SUMMARY

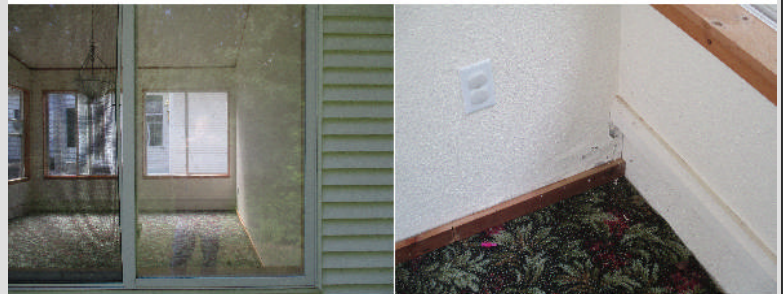
One cracked window and some prior moisture was noted on the screen house.

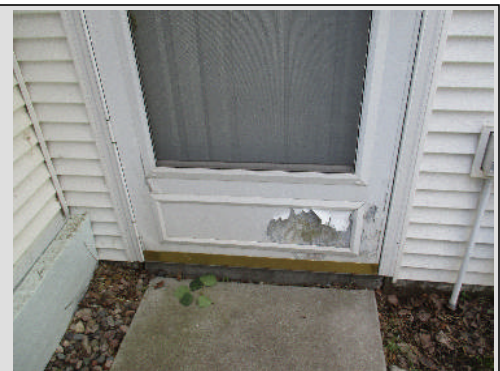
Outside Entry Door: The outside entry door to the garage is satisfactory. The rear storm door is in need of repair or replacement.
