Report Index

INSPECTION CONDITIONS

**5220 Mockingbird Lane
Atlanta, GA 30328**

Inspection conducted by Paul Davidson
GAHI#345-98

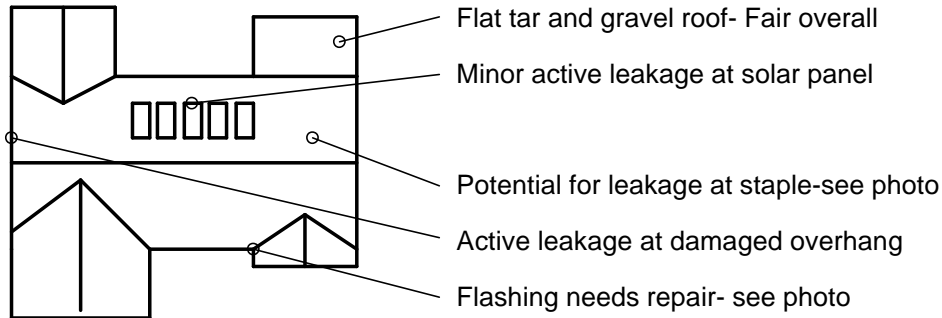
PLAN VIEW OF ROOF (not to scale)

General condition appears serviceable with signs of weathering/curling and aging. [This roof is now 12 years old.](#) Regular maintenance and inspections are advised so you can make reinforcements as needed to prolong roof

life. **Some repairs are needed now.** Nails/Fasteners are protruding from the roof surface at the rear of the roof, and flashing is uplifted and in need of repair at the front right gable. Each of these areas represents a potential area of leakage, if not now, then in the near future. [A licensed roofing contractor should](#)

Aluminum. Damage is noted- along the overhang at the left side of the house. **Active leakage is noted within the attic area** under this portion of the roof, as shown in the 2nd photo. A licensed roofing contractor should be called to make further evaluation and repairs as needed.

be called to make further evaluation and repairs as needed.
